CANADIAN FORCES FLIGHT SAFETY INVESTIGATION REPORT (FSIR)

FINAL REPORT

FILE NUMBER: 1010-Gliders (DFS 2-4-2)
DATE OF REPORT: 8 April 2005

AIRCRAFT TYPE: Schweizer 2-33A Glider, C-GDZF
DATE/TIME: 241640Z July 2003
LOCATION: Central Region Air Cadet Gliding School, Picton, Ontario
CATEGORY: "B" Category Accident

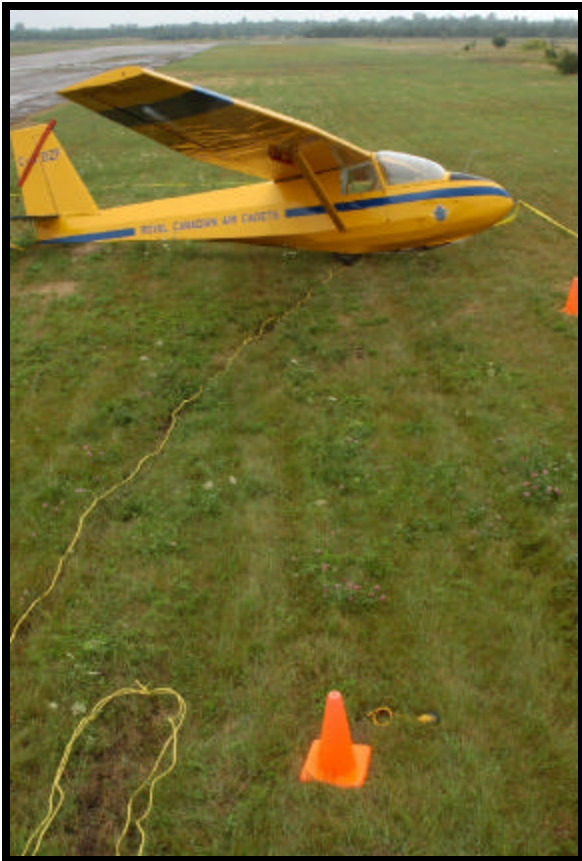
In a near-level attitude heading approximately 25° to the left of the landing direction, the glider's main skid and wheel and the right-wing tip struck the wet, grass landing strip about 300 feet past the LCO truck. The glider then rotated 30° to the right and bounced back up into the air. It struck the ground again and continued to rotate to the right as it slid across the landing strip. The glider finally came to rest with its left wing down and facing approximately 120° right from the direction of landing (Photo 1). Both occupants then egressed unassisted.

The wreckage site was on the grass landing strip on the south side of runway 05. Ground scarring from the right wingtip and main landing skid was evident on the wet grass landing strip and was consistent with the observed aircraft damage. The initial impact scarring was 250 feet past the LCO truck.

Photo 1: Final Resting Place

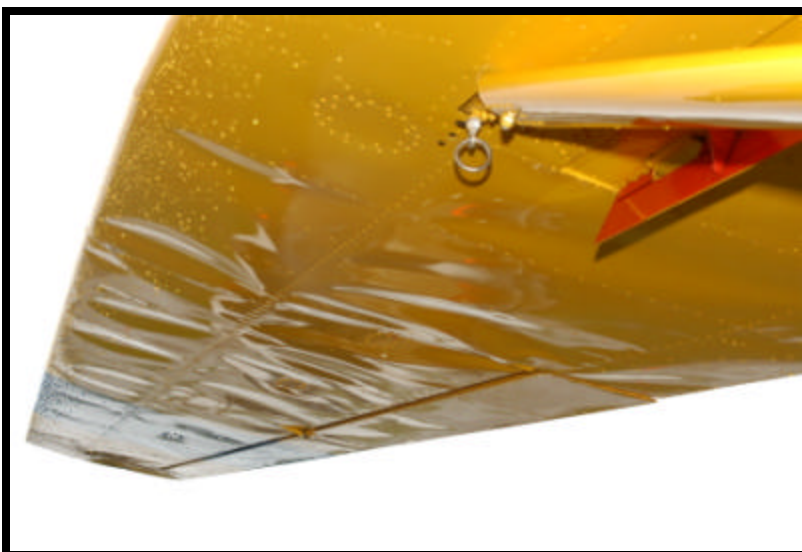
The glider's right outrigger was torn from its wingtip mounting. The underside of the right wing's mid-section skin buckled (Photo 2) while the leading edge skin parted between skin panels.

The glider sustained "B" category damage.

Photo 2: Right Wing Damage
